Belzona 1151 cold plate bonding on a Blast Door

ID: 8494

Customer Location: Nuclear power plant
Application Date: May 4th 2021

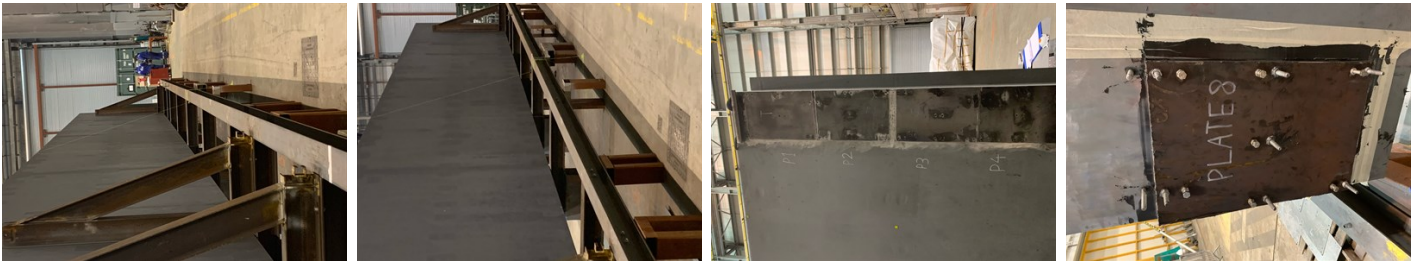
24m steel blast door slightly of square causing fouling on roller system operation. Although the door is square across the length there is a slight twist in the steel at either end which needs to have a tolerance of zero mm

- * 1. Picture of blast door ,
- * 2. Picture of blast door ,
- * 3. Close up of plates ,
- * 4. Close up of plate application ,

Belzona 1151 was applied to substrate along with sacrificial shim plates to leave a flush steel finish for the roller system to be able to function correctly. The belzona was applied in various thicknesses from 1mm to 6mm to achieve a plum finish from top to bottom.
