# Belzona Guides its Clients into Rebuilding & Protecting an Assembly Line

## Buffer Chain Guide

Levelling off wear at the bottom of a buffer chain guide on an automotive assembly line.

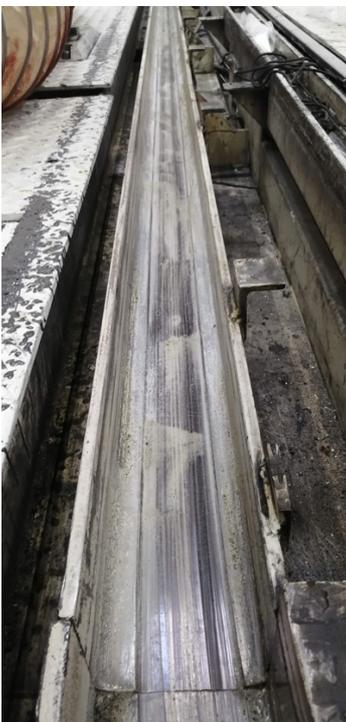
*The conveyor chain had worn the channel that guides it by 6-8mm over a period of 10 years.*

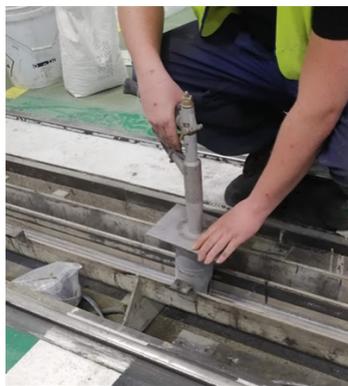
The client couldn't afford to have any dust in the vehicle assembly block, this forced the Distributor to form their own grit blasting nozzle allowing them to not only blast but also contain and recuperate the grit, minimising the spread of dust. The client was astonished by not only the Distributors ability to work within tight constraints but also by the possibility of using Epoxies to repair rather than replace the whole chain guide.
