Belzona Guides its Clients into Rebuilding & Protecting an Assembly Line

Buffer Chain Guide

Levelling off wear at the bottom of a buffer chain guide on an automotive assembly line.

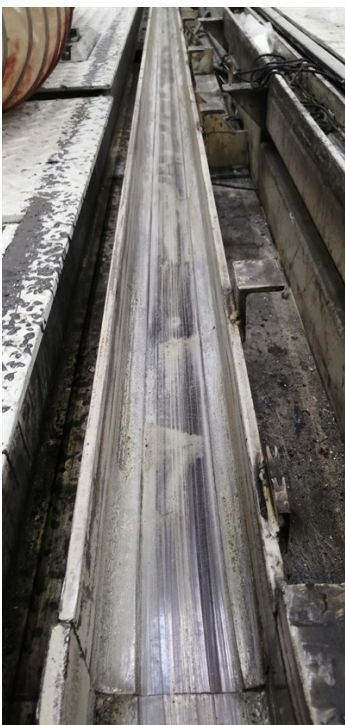
The conveyor chain had worn the channel that guides it by 6-8mm over a period of 10 years.

- * 1). Problem Area ,
- * 2). Specific Grit-blasting Dust Extraction Tool ,
- * 3). Application of Belzona 1311 ,
- * 4). Final Application ,

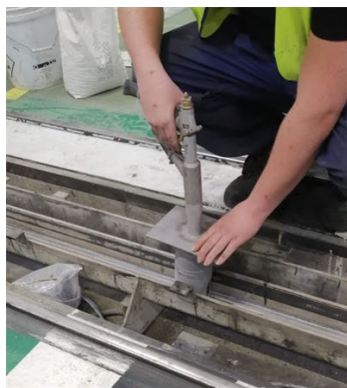
The client couldn't afford to have any dust in the vehicle assembly block, this forced the Distributor to form their own grit blasting nozzle allowing them to not only blast but also contain and recuperate the grit, minimising the spread of dust. The client was astonished by not only the Distributors ability to work within tight constraints but also by the possibility of using Epoxies to repair rather than replace the whole chain guide.
