Belzona Tank Base Sealing System Applied to Nitrogen Tank

Customer Location: Industrial gas supplier, UK
Application Date: June 2021

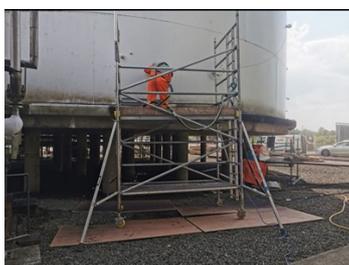
The tank had developed a void between its annular ring and plinth substrate. The asset owner had concerns that if the void had been left to deteriorate, adverse weather conditions and moisture/condensation would accumulate and track under the base of the tank. This would inevitably lead to corrosion of the tank base, leakage or even a tank failure.

- * 1. 15m diameter tank to be repaired ,
- * 2. Belzona 4131 being applied ,
- * 3. Tank base sealing system in progress ,
- * 4. Completed application ,
