# Belzona Tank Base Sealing System Applied to Nitrogen Tank

ID: 8529

Customer Location: Industrial gas supplier, UK  
Application Date: June 2021

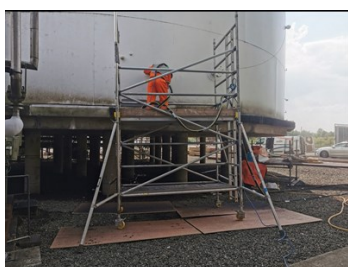
The tank had developed a void between its annular ring and plinth substrate. The asset owner had concerns that if the void had been left to deteriorate, adverse weather conditions and moisture/condensation would accumulate and track under the base of the tank. This would inevitably lead to corrosion of the tank base, leakage or even a tank failure.

- \* 1. 15m diameter tank to be repaired ,
- \* 2. Belzona 4131 being applied ,
- \* 3. Tank base sealing system in progress ,
- \* 4. Completed application ,

Once the substrate has been prepared to a standard of minimum surface profile of 75µm and a surface cleanliness of SA 2½, Belzona applicators rebuilt the damaged areas under the annular ring using Belzona 4131 to a 45° fillet which will encourage water flow away from the tank. Once complete the Belzona Tank Base Sealing system was applied in accordance with Know-How system leaflet GSS-03 using Belzona 3131 at a 500mm wide band around the complete circumference.
