Ash Silo repaired with Belzona 1818

ID: 8535

Customer Location: Coal fired power station, Australia
Application Date: June 2021

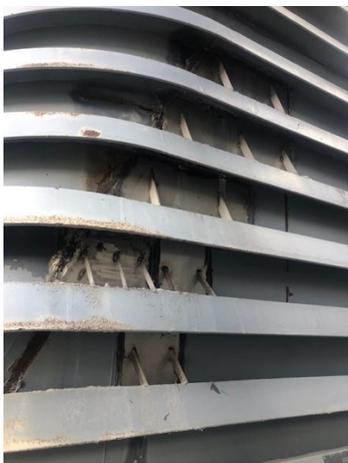
They have been experiencing rapid wear in the bottom part and particularly the Northern wall of the Bottom Ash Silo. The silo is made of 3CR12 grade stainless steel at 8.0mm thick. The wear rate is 0.25mm of wall thickness loss per month. The customer needed a quick solution to protect what metal they had left.

- * Picture 1: External view of the damaged Silo ,
- * Picture 2: Internal view of the damaged Silo ,
- * Picture 3: Belzona is applying ,
- * Picture 4: Application complete ,

There were areas in the Silo walls that had worn down from 8.0mm to 3.8mm of remaining wall thickness. Rezitech were called to offer a quick solution to reduce the metal loss and protect the remaining substrate. 20 X 1 kg kits of Belzona 1818 were applied.
