# Belzona takes the floor

Industry: Buildings & Structures  
Application: FPA-Floor Problem Areas  
Substrate: Concrete  
Products: \* Belzona 4981 ,  
\* Belzona 5892 ,

Customer Location: Spain  
Application Date: June 2021

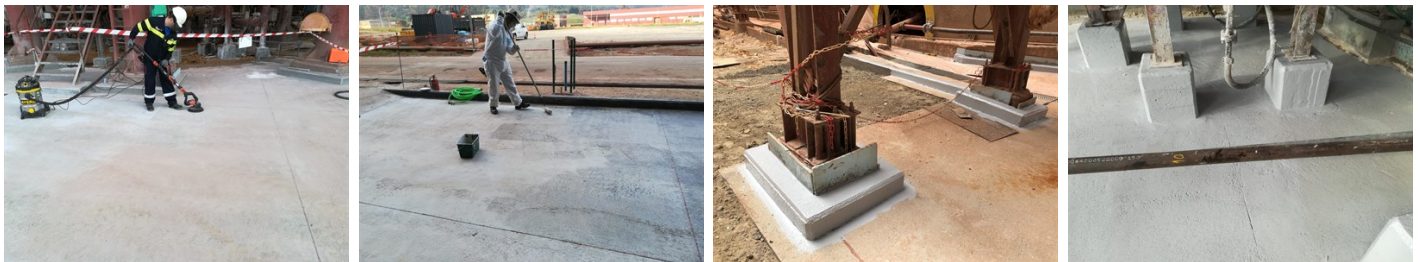
## Photograph Descriptions

Equipment within the flooring area stores and processes chemicals including Sodium Hydroxide and Potassium Hydroxide at temperatures up to 80C. In case of spillage, the bare concrete would be easily attacked, therefore a protective system is required.

- \* 1. Preparation of concrete floor ,
- \* 2. Application of Belzona 4981 ,
- \* 3. Belzona 5892 applied to plinths ,
- \* 4. Completed Application ,

The application was carried out in accordance with a modified version Belzona Know-How System Leaflet FPA-3. After allowing the concrete to dry for 28 days, the concrete floor was prepared by vacuum cleaning to remove dust and loose particles, leaving a clean, dry and firm substrate. Belzona 4181 was applied to the area to prevent outgassing and provide excellent adhesion to the concrete. Belzona 5892 was then applied as a 2-coat system to protect the concrete from chemical spillage and provide a robust flooring surface for regular foot traffic.
