Belzona Strengthens Nozzles of Heating Medium Expansion Vessel on Offshore Platform

ID: 8573

Customer Location: China
 Application Date: 2017

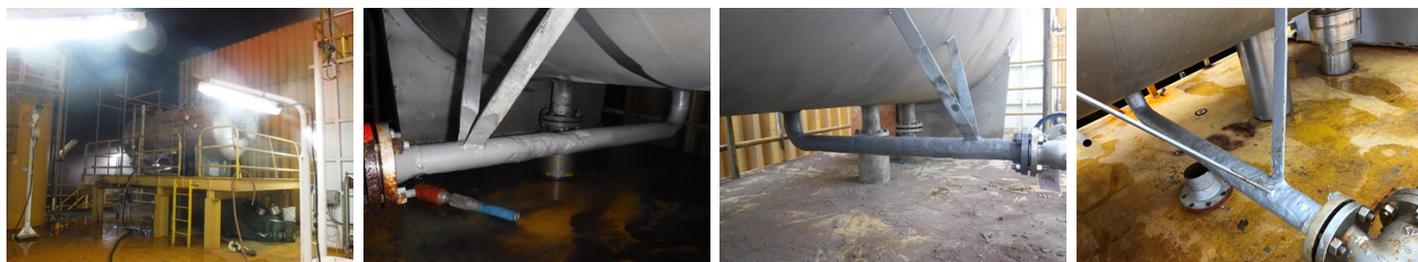
Photograph Descriptions

The nozzles of heating medium expansion vessel had developed thin-wall defect due to CUI.

- * 1. Surface preparation ,
- * 2. Condition of nozzles after sandblasting ,
- * 3. Complete application of Belzona Superwrap II ,
- * 4. View of nozzles after 3 years ,

Nozzles of heating medium expansion vessel on offshore platform suffering from corrosion and significant thickness loss. The design pressure is 0.3MPa, the design temperature is 180°C.

The application was completed in accordance with Belzona System Leaflet VPF-11, with Belzona 1511 and 3 layers of Belzona 9341 applied. The whole application involved 2 two-inch nozzles.

hazards. Therefore, the customer has been looking for the solutions with no hot work required but also accepted by classification society. Belzona solution can repair the nozzles of pressure vessels on-site, with no hot work required, reducing downtime and the loss of production. This repair system has also passed the MQT test of BV. The application is still in good condition after 3 years.
