BELZONA SUPERWRAP II EXTENDS LIFE OF PIPING BY 10 YEARS

ID: 8574

Customer Location: Western Australia
Application Date: October 2020

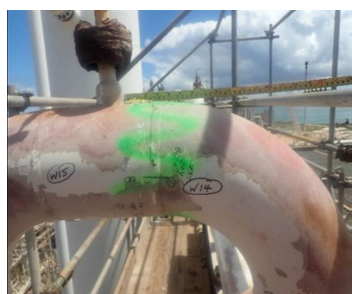
The 250 mm diameter pipe had developed a critical (Class 3) through wall defect at the bent. The operating temperature was 50°C and the operating pressure was 15 bar.

- * 1. Defect area of the pipe ,
- * 2. Surface abrasive blasted ,
- * 3. Application in progress ,
- * 4. Release Film over the wrap waiting to cure ,
