# BELZONA SUPERWRAP II EXTENDS LIFE OF PIPING BY 10 YEARS

ID: 8574

Application: VPF-Valves, Pipes and Fittings

High Pressure, Fuel Oil Piping

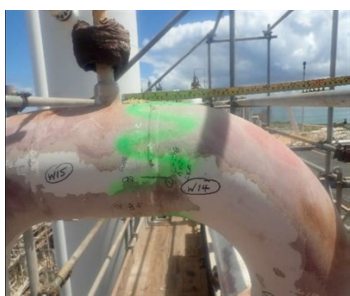
The 250 mm diameter pipe had developed a critical (Class 3) through wall defect at the bent. The operating temperature was 50°C and the operating pressure was 15 bar.

- \* 1. Defect area of the pipe ,
- \* 2. Surface abrasive blasted ,
- \* 3. Application in progress ,
- \* 4. Release Film over the wrap waiting to cure ,
