# BELZONA SUPERWRAP II EXTENDS LIFE OF A HIGH TEMPERATURE PIPELINE BY 5 YEARS

Industry: Oil & Gas  
Application: VPF-Valves, Pipes and Fittings  
Substrate: Carbon Steel (Grade: ASTM A106B)  
Products: \* Belzona 1511 (Super HT Metal) ,  
\* Belzona 1983 (SuperWrap II Resin) ,  
\* Belzona 9381 (SuperWrap II Reinforcement Sheet) ,  
\* Belzona 9382 (Release Film) ,

Customer Location: Victoria, Australia  
Application Date: December 2020

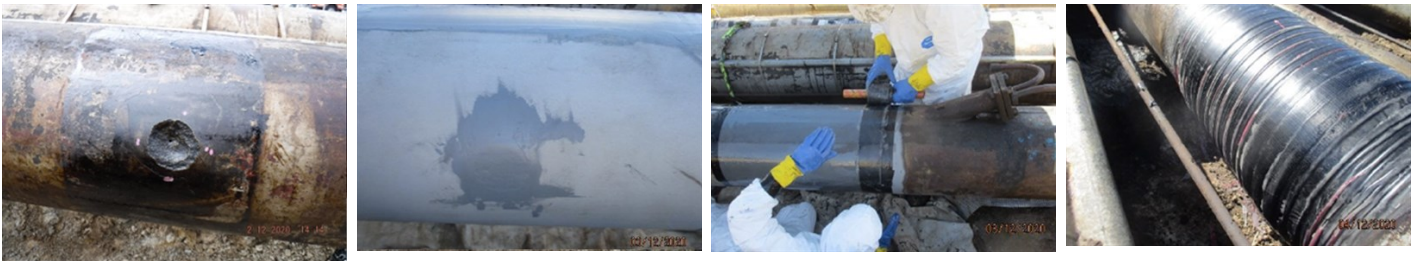
The 406 mm diameter pipe had developed a critical (Class 3) through wall defect calculated at 40 x 40 mm. The operating temperature was 90°C and the operating pressure was 17.6 bar. The total defect length was 90 mm in axial.

- \* 1. Defect in the pipe ,
- \* 2. Defect pit filled with Belzona 1511 ,
- \* 3. Application in progress ,
- \* 4. Application completed ,

The application was completed in accordance with Belzona Know-How System Leaflet VPF-11. After the surface preparation by grit blasting to achieve SA 2.5 with a 75 microns profile, Belzona 1511 was applied to the critical defect area to fill and smooth out before wrapping. Belzona SuperWrap II was then applied in accordance with the engineered design as an 11 wrap system with the total length of 540 mm, using Belzona 1983 resin to provide a further 10 years service life.

Belzona SuperWrap II was chosen because it is an engineered solution that can be designed as a pipe repair system being compliant to ISO 24817 and ASME PCC-2. The Belzona 1983 resin was chosen due to its high heat resistance of up to 150°C. The repair was designed by Belzona Engineer and the application was completed by applicators who are trained and validated to apply Belzona SuperWrap II.
