BELZONA SUPERWRAP II REPAIRS UNDERGROUND PIPELINE ADDING 15 YEARS SERVICE LIFE

ID: 8576

Industry: Oil & Gas

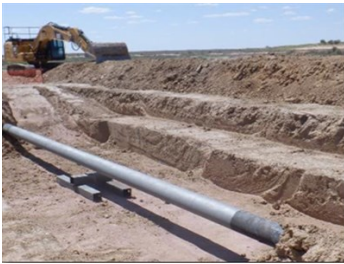
- * 1. Pipe being excavated ,
- * 2. Wetting out the substrate with Belzona 1982 resin ,
- * 3. Release film over the wrap waiting to cure ,
- * 4. Completed 8.1 m long application ,
