BELZONA SUPERWRAP II REPAIRS UNDERGROUND PIPELINE ADDING 15 YEARS SERVICE LIFE

Customer Location: Victoria, Australia

Application Date: July, 2020

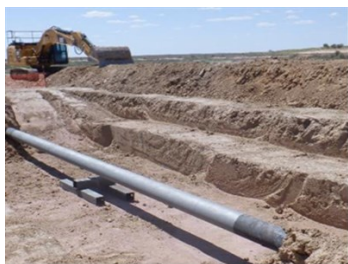
- * 1. Pipe being excavated ,
- * 2. Wetting out the substrate with Belzona 1982 resin ,
- * 3. Release film over the wrap waiting to cure ,
- * 4. Completed 8.1 m long application ,

The application was completed in accordance with Belzona Know-How System Leaflet VPF-11. After the surface preparation by grit blasting to achieve SA 2.5 with a 75 microns profile, Belzona 1111 was applied to the critical defect area to fill and smooth out before wrapping. Belzona SuperWrap II was then applied in accordance with the engineered design as a 9 wrap system with the total length of 540 mm, using Belzona 1982 resin to provide a further 15 years service life.
