Belzona 7211 Deep Pour Grout for Tank Base

ID: 8581

Industry: *Chemical & Petrochemical*
Application: *TCC-Tanks and Chemical Containment Areas*

Problem

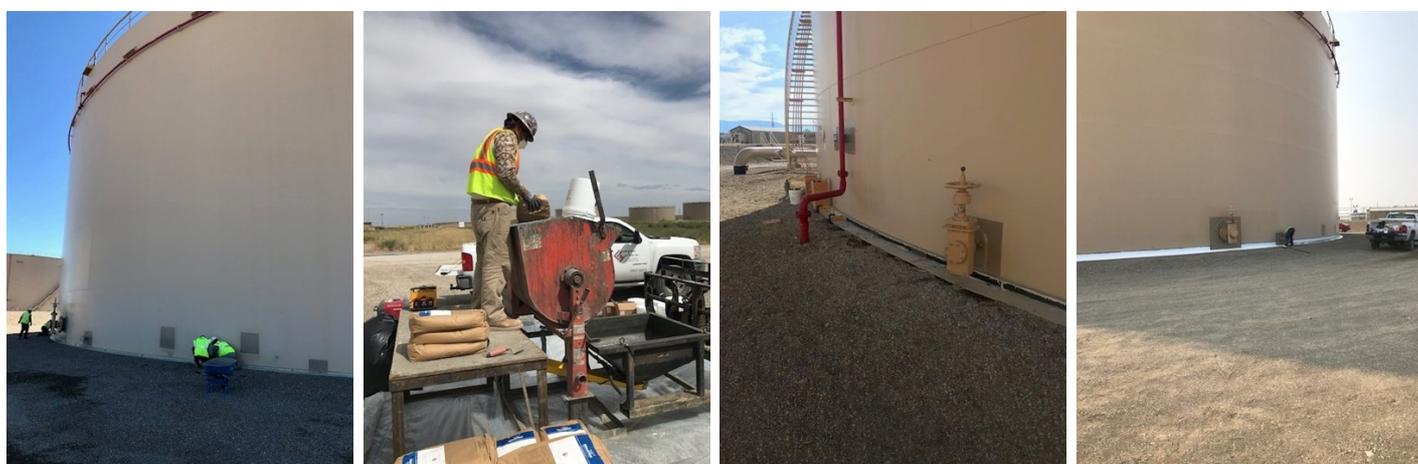
Photograph Descriptions

The wall of this petroleum storage tank had heavy loads on it, but the base of the tank wall was not resting on the annular ring.

- * 1) Sections of failing Cementous grout easily removed in sections. ,
- * 2) Belzona 7211 mixed and transported to pour site where form work and head boxes were installed. Belzona 5811 was used in sections less than 2" deep. ,
- * 3) View of a section being poured next to previously poured section. Work was done in sections to prevent excessive loads without a base. ,
- * 4) Belzona 5111 being applied to provide an UV resistant coating over grout. ,

Application required filling the existing gap between the tank annular ring and base.

A head box was used to apply the material with simple form work.

The ability to grout the tank with proper materials put this tank back in service as it could not be used in this condition. This increased the storage capacity at this terminal considerably and restored this asset. Belzona 7211 and 5811 will not shrink and have high compressive loads preventing future failure and water ingress that causes freeze thaw problems.
