# Belzona provides Leading Edge Protection (LEP)

ID: 8583

Industry: Power  
Application: FBC-Fans, Blowers and Compressors

Customer Location: Doncaster  
Application Date: September 2021

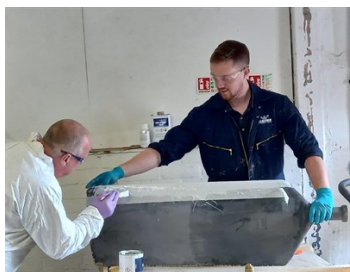
A cooling tower with 4 x 9m $\phi$  cells, each with 9 x 4.5m blades was to be refurbished, the main part of the works was to replace the blades. This was mainly due to wear and expected erosion leading to failure of the blades. Our client stepped in to offer a solution to keep the existing blades and coat them to protect the client's assets

- \* 1. Training taking place ,
- \* 2. Blades awaiting preparation ,
- \* 3. Finished blades awaiting dispatch to site ,
- \* 4. Closer detail of finished LEP and full body protection coating ,

Training was given from the UK Sales Technical team to the contractors at their works. The blades were sanded to provide a key, then 2 x coats of 5811 were applied to the total surfaces of the fan blades. After curing, the 5811 was again abraded along on the leading edge, approx 80mm either side of the blade's leading edge to the length of the blade. 2 coats of 5721 were then applied to complete the protective application.
