LED Light Fixture Bonding with Belzona onto a Hospital Roof

ID: 8591

Industry: *Buildings & Structures*
Application:
Substrate: *Steel Coping and Concrete Pillars*
Products: ** Belzona 4911 (Magma TX-conditioner) ,*
** Belzona 1161 (Super UW-Metal) ,*

Customer Location: *Houston*
Application Date: *2020-2021*

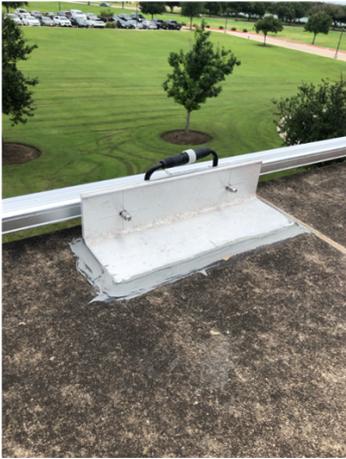
- * 1. Close up of concrete bonding location ,
- * 2. Overall Picture ,
- * 3. Application onto metal coping. ,
- * 4. View of fixture system ,

Aluminum angle brackets were to be bonded to the substrate in order to bolt on LED fixtures. The bottom of the brackets together with the substrate were prepared with a grinder to create a rough and clean profile. Belzona 4911 primer was used in all concrete locations. Belzona 1161 was applied to both the bracket bottom and substrate at about 1/16" inch thick. The bracket was then firmly pressed down to the substrate and exuded material was used to chamfer around the edges. Once in place, holes were drilled into the brackets and the LED fixtures were installed.
