# LED Light Fixture Bonding with Belzona onto a Hospital Roof

ID: 8591

Substrate: Steel Coping and Concrete Pillars

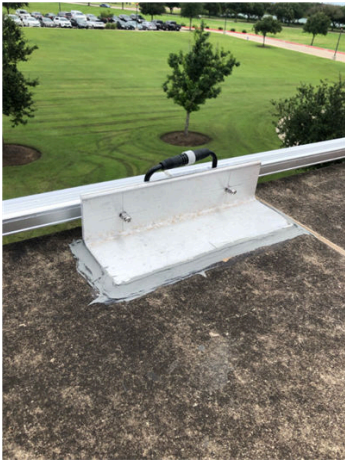
- \* 1. Close up of concrete bonding location ,
- \* 2. Overall Picture ,
- \* 3. Application onto metal coping. ,
- \* 4. View of fixture system ,

Aluminum angle brackets were to be bonded to the substrate in order to bolt on LED fixtures. The bottom of the brackets together with the substrate were prepared with a grinder to create a rough and clean profile. Belzona 4911 primer was used in all concrete locations. Belzona 1161 was applied to both the bracket bottom and substrate at about 1/16" inch thick. The bracket was then firmly pressed down to the substrate and exuded material was used to chamfer around the edges. Once in place, holes were drilled into the brackets and the LED fixtures were installed.
