# BELZONA WEATHERPROOFS INSULATED ROOFTOP DUCTING

**Customer Location:** *Ivy League Medical School*

**Application:** *HEX-Heat Exchangers*

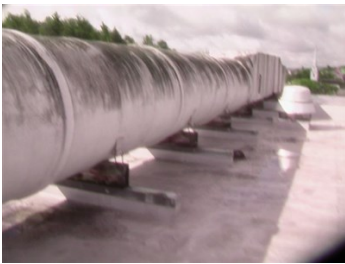
*Original protection no longer water-tight. Insulation was wet and water was leaking into the building. CUI was feared.*

\* Degraded insulation on ducts , \* Degraded insulation at building interface , \* Recoated and protected with Belzona , \* Summer 2007 still as good as new! ,

The original plan was to remove all wet existing insulation and re-insulate and waterproof over 200 feet of 60 inch carbon steel ducts.

Micro-porosity of Belzona system allowed existing insulation system to dry out so restoring protection and efficiency.

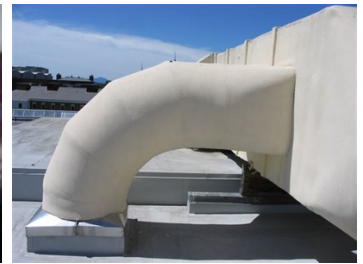
System still excellent 3 years on.
