# BELZONA EXTENDS LIFE OF REDUCTION FLANGE IN CORN MILL

ID: 865

Industry: *General Industry*  
Application: *SHM-Solids Handling Machinery*

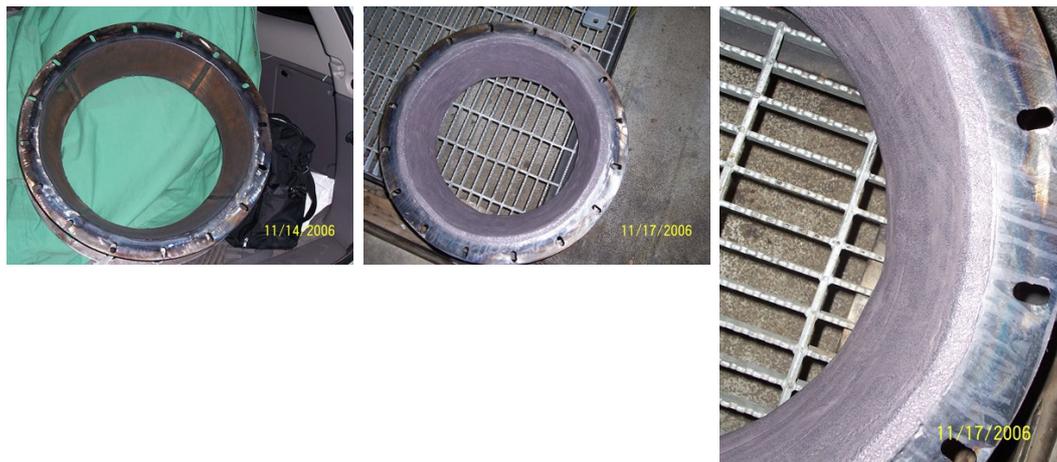
*16" hose reduces to 14" pipe and at this point there is severe wear limiting life to 6 weeks.*

\* Uncoated reduction flange , \* Reduction flange lined with Belzona 1812 , \* Close up of lined flange ,

Applicaition was carried out using Belzona System SHM-7.

This extended the life of the flange from 6 weeks to 6 months saving downtime and the expense of having to change it out.
