# Slippery metal? Belzona It.

ID: 8653

Application: FPA-Floor Problem Areas

Metal diamond plate underground vault cover.

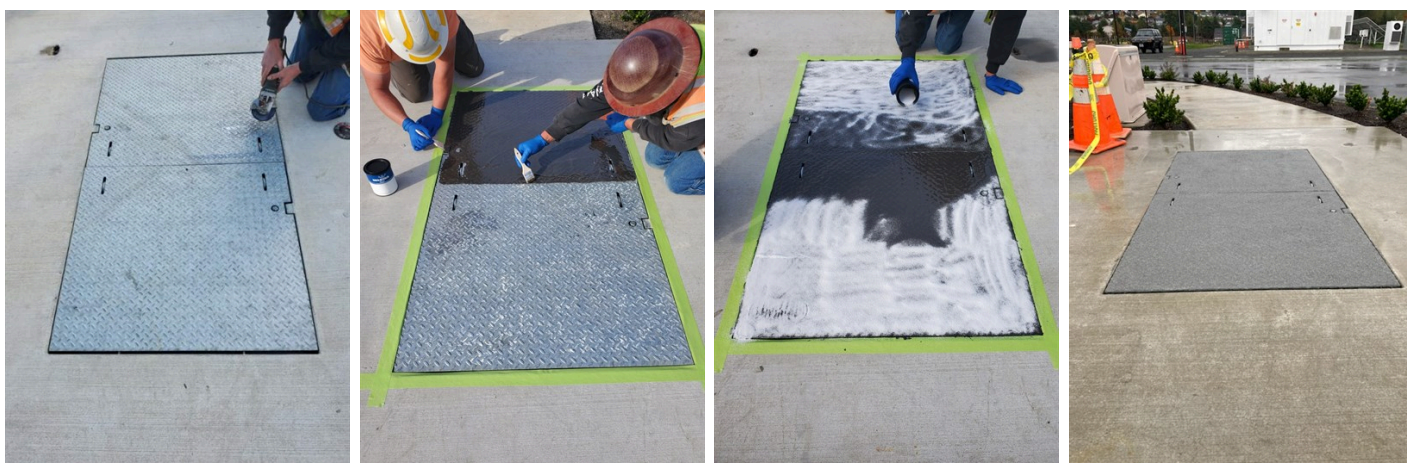
## Photograph Descriptions

Even though the vault cover was diamond plate, it was found to be slippery when wet. At the location of this vault, it rains 150 days per year on average, resulting in a slippery surface in the middle of a sidewalk for almost half of the year.

- \* 1. Grinding the surface of the vault cover ,
- \* 2. Applying the Belzona 1821. ,
- \* 3. Applying the Belzona 9221. ,
- \* 4. Application complete. ,

A grinder was used to roughen the surface, and then washed down with solvent to clean off any contamination. The Belzona 1821 was mixed and applied by brush to ensure maximum adhesion, and finished by using an applicator to spread it out evenly. The Belzona 9221 aggregate was then sprinkled to refusal and packed into place using a wooden block. After 4 hours, the excess aggregate was vacuumed up leaving a clean non-slip finish.
