Belzona Saves Cast Aluminium Mandrel

ID: 8699

Industry: Mining & Quarrying
Application: MPT-Mechanical Power Transmission

Substrate: Aluminium
Products: * Belzona 1511 (Super HT-Metal),

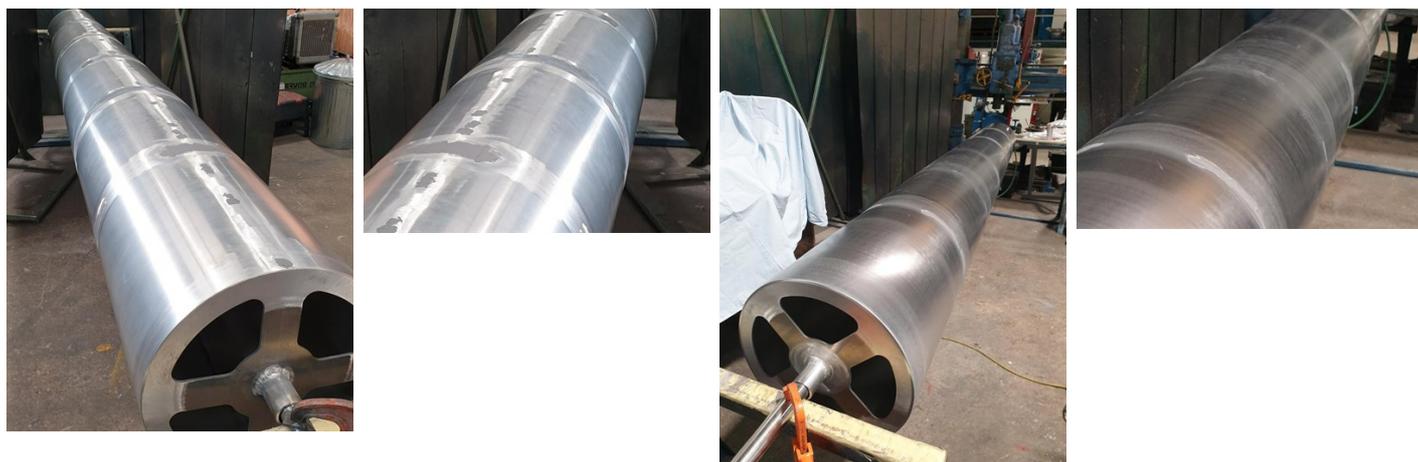
Photograph Descriptions

The surface of the mandrel had been compromised and the engineering company's brief was to return the mandrel to a smooth surface finish.

- * 1. Belzona 1511 applied ,
- * 2. Belzona 1511 applied (close-up) ,
- * 3. Mandrel repair complete with Belzona 1511 smoothed ,
- * 4. Close up of completed works ,

The product was applied in accordance with Belzona System Leaflet MPT-1. After surface preparation, the Belzona 1511 was applied to the surface and smoothed down until it sat flush with the aluminium substrate.

The application was carried out by the engineering company, saving costs against employing an applications contractor. The alternatives would have been aluminium welding and machining. The hot works could have compromised the 4m Mandrel. Using 1kg of Belzona 1511 enabled a swift, cold applied repair and a rapid return to service.
