BELZONA CONTAINS SULFURIC ACID

Industry: Chemical & Petrochemical
Application: TCC-Tanks and Chemical Containment Areas
Substrate: Concrete
Products: Belzona® 4311 (Magma CR-1)
Belzona® 4131 (Magma Screed)

Customer Location: Ethanol Plant, Iowa, USA
Application Date: April 2007

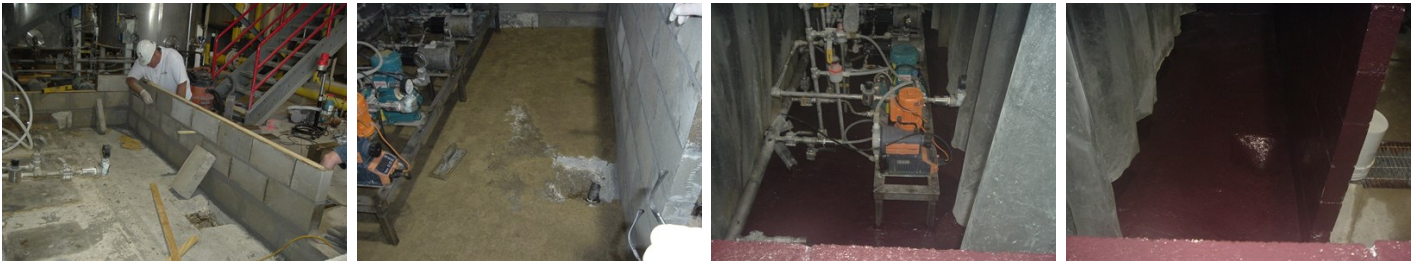
Photograph Descriptions

Sulfuric acid leaks were eroding concrete pump bases as well as floor in small containment area

* Concrete block being laid with Belzona® 4131 as mortar , * Floor sloped to the drain , * Pumps back in service , * Completed drain ,

Application was carried out in accordance with modified Belzona System Leaflets TCC-9 & 15. Concrete blocks were laid using Belzona® 4131 as mortar. Floor was re-profiled and sloped so any spill would run towards the drain. The entire floor and walls were coated with Belzona® 4311.
