# Apple Cidery Loading Bay Coated with Belzona

ID: 8756

Application: FPA-Floor Problem Areas

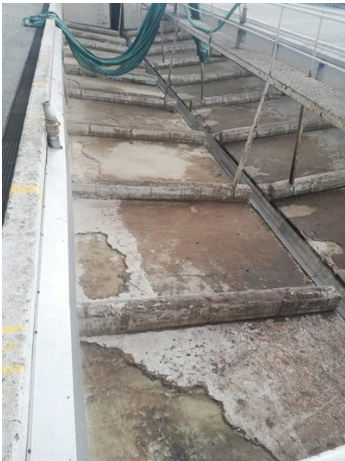
Lorries would arrive on site and dump apples into the loading bay. The juices from the apples were acidic, and over time started to degrade the concrete bay and chemical channel flowing through the bay

- \* 1.) Loading bay prior to application ,
- \* 2.) Surface preparation - Concrete scarifier + UHP ,
- \* 3.) Chemical channel rebuilt with Belzona 4111 + 1st coat of Belzona 5231 being applied ,
- \* 4.) Finished application - 2 coats of Belzona 5231 applied ,
