# Apple Cidery Loading Bay Coated with Belzona

Application: FPA-Floor Problem Areas

Substrate: Concrete

Products: \* Belzona 4111 (Magma-Quartz) Belzona 5231 (SG Lamine),

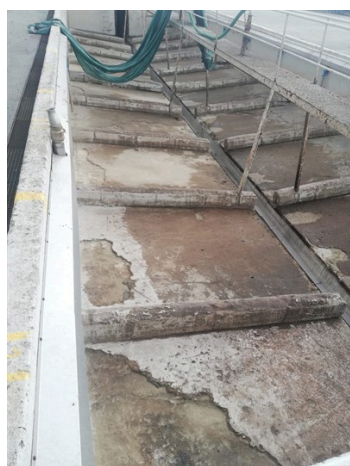
Lorries would arrive on site and dump apples into the loading bay. The juices from the apples were acidic, and over time started to degrade the concrete bay and chemical channel flowing through the bay

- \* 1.) Loading bay prior to application ,
- \* 2.) Surface preparation - Concrete scarifier + UHP ,
- \* 3.) Chemical channel rebuilt with Belzona 4111 + 1st coat of Belzona 5231 being applied ,
- \* 4.) Finished application - 2 coats of Belzona 5231 applied ,

This application was carried out in accordance with system leaflet FPA-03. The first step was to remove and dispose of any loose concrete. Once the bulk of the loose concrete had been removed, a concrete scarifier was used to roughen up the substrate before being pressure washed down using UHP (Ultra-High Pressure) water jetting. Once the concrete was prepared, Belzona 4111 was used to rebuild the edges of the chemical drain before 2 coat of Belzona 5231 were applied to the whole bay (270m<sup>2</sup>).
