BELZONA PROVIDES CORROSION PROTECTION AND SEALING BETWEEN CLAMP AND PROPELLER SHAFT

ID: 8781

Customer Location: *RO – RO SHIP, TURKEY*

Application Date: *NOVEMBER, 2021*

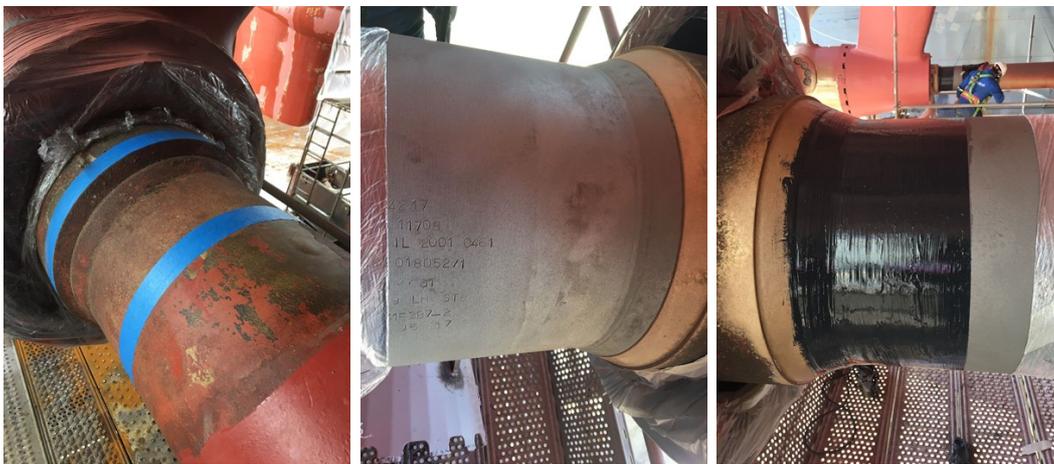
Photograph Descriptions

The Ship Owner wanted to be sure clamp sealings on propeller shafts can resist to seawater and to clamps itself.

* 1. Area wanted to be sealed 2. Surface preparation with grit blasting 3. After completing Belzona Elastomer application ,

PROPELLER SHAFT REQUIRES NEW CLAMP SEALINGS

The application was carried out in accordance with Belzona System Leaflet GSS-01. Propeller shaft was grit blasted and cleaned. Belzona 2911 Conditioner was used on surface as a thin layer. After the touch dry time passed Belzona 2211 Elastomer was applied on the marked area.
