# Belzona Protects Inlet Spools of an Alstom Seawater Pump

ID: 8787

Customer Location: Jorf Lasfar, Morocco  
Application Date: November 2020

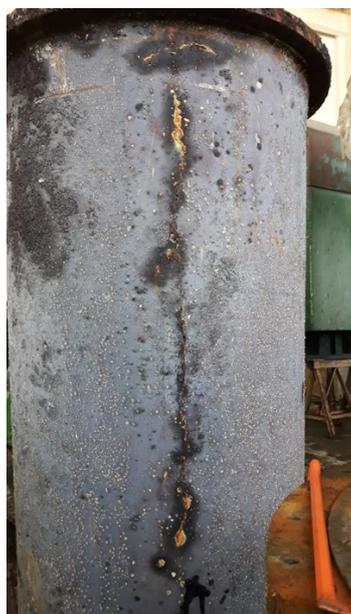
The inlet spool of an Alstom sea pump was cracked (1500mm along the length of the spool) on the outside and suffered corrosion due to sea water, therefore needing to be repaired and protected against future wear along with other parts of the pump.

\* 1). Original condition of the Inlet Spool. 2). Surface preparation, termination and V-ing out of the 1500mm crack. 3). Reloading of the inlet spool crack and partial coating application. 4). Completed application overcoated with Belzona 1321. ,
