Oil Refinery Adopts Belzona Composite Pad for Pipeline Repair

ID: 8870

Customer Location: Oil Refinery Operator - Australia
Application Date: January 2022

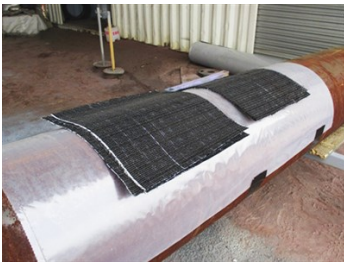
- * 1. Reinforcement Sheets Cut to Required Size ,
- * 2. Wetting out Reinforcement Sheets ,
- * 3. Reinforcement Sheets Applied to Pipe Contour ,
- * 4. Belzona Composite Pad Bonded to the Pipeline ,

A Belzona SuperWrap II Composite Pad was fabricated to the exact dimensions of the pipe, on-site by qualified SuperWrap II Contractors. The cured Composite Pad was then bonded in place using Belzona 1111 (Super Metal). Due to its lightweight nature, the application could be applied by just two technicians.
