# Belzona Super Wrap II on High Pressure Pipe Offshore

ID: 8878

Industry: Oil & Gas  
Application: SOS-Ships and Offshore Structures

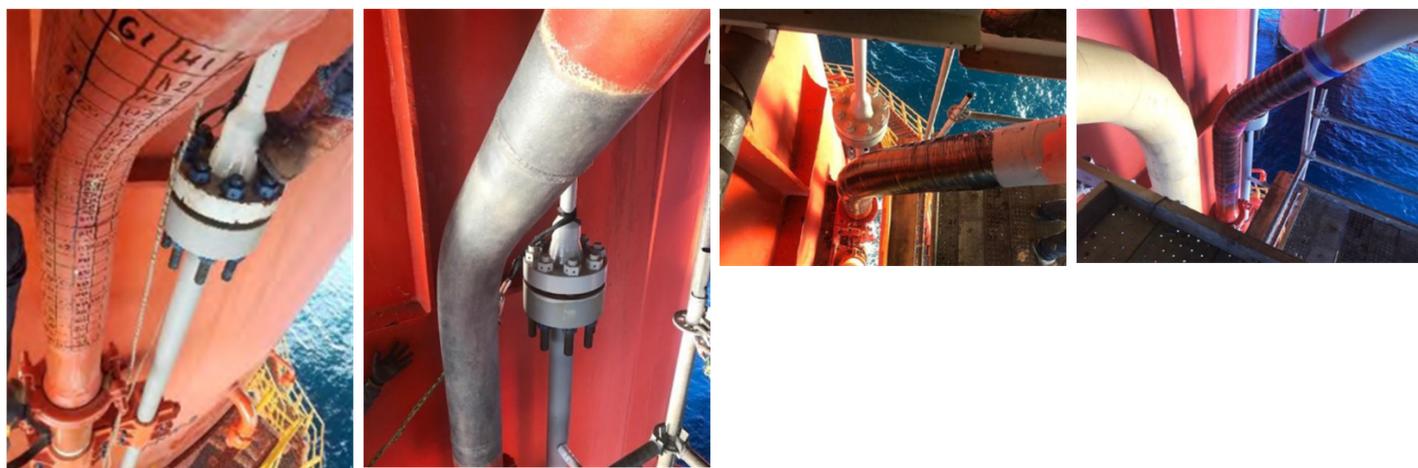
The pipe is a very important part of oil & gas operations for this customer. The application area was difficult to access. External corrosion created thinning of the wall thickness on the pipe causing a solution to be found to protect this pipe.

An 8in diameter liquid hydrocarbon line of a major Oil & Gas Owner on an offshore platform in the Gulf of Mexico experienced external corrosion. UTS was performed to determine the wall thickness of the pipe. The MAWP of the line is 5000psi. The application area was reached via Rope Access. SuperWrap II was chosen as a preventative measure to protect the pipe. Replacement costs are not feasible at this time and a shut in would require a major loss in cash flow.

1. Power tool prep via MBX Bristle Blaster to bare metal (SSPC-SP11). Wipe the surface clean with Belzona 9111 and let dry.
2. Belzona 1161 was applied to the thin wall areas.
3. Belzona SuperWrap II system was applied per the design at 3 wraps / 18in axial extent. Belzona 9382 was used to consolidate and allow to cure.
