External corrosion protection for valve parts

ID: 8882

Industry: *Chemical & Petrochemical*
Application: *GSS-Gaskets, Seals and Shims*
Substrate: *Carbon steel*
Products: *Belzona 8411*
Belzona 3412

Customer Location: *Scotland*
Application Date: *July 2022*

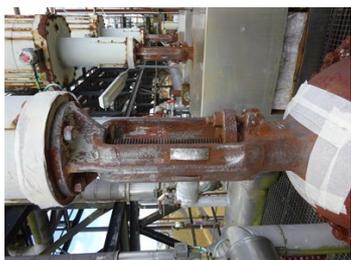
Area taped out

The exposed steel was first prepared to a ST-2 standard. Belzona 8411 was then applied followed by two coats of Belzona 3412

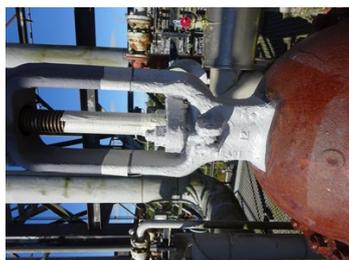
1st coat of Belzona 3412 applied

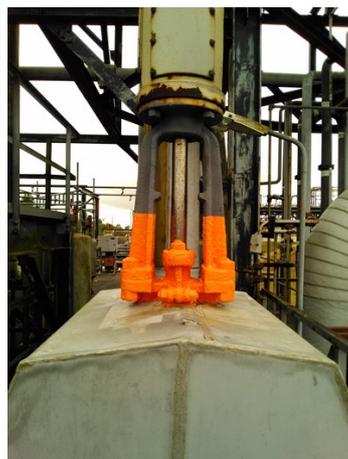
Close up of application

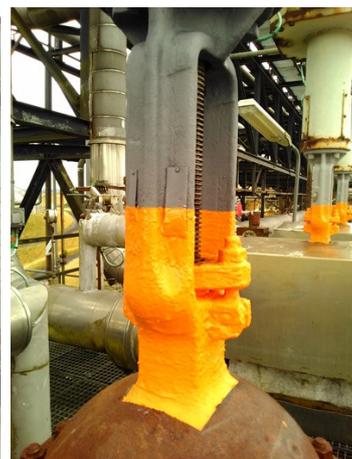
Completed application
