External corrosion protection for valve parts

ID: 8882

Industry: Chemical & Petrochemical
Application: GSS-Gaskets, Seals and Shims
Substrate: Carbon steel
Products: Belzona 8411
Belzona 3412

Customer Location: Scotland
Application Date: July 2022

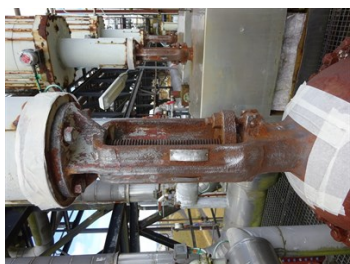
Area taped out

The exposed steel was first prepared to a ST-2 standard. Belzona 8411 was then applied followed by two coats of Belzona 3412

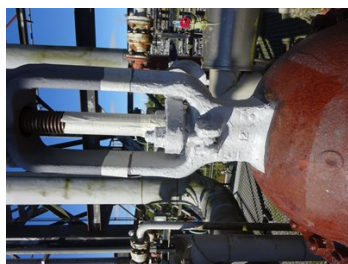
1st coat of Belzona 3412 applied

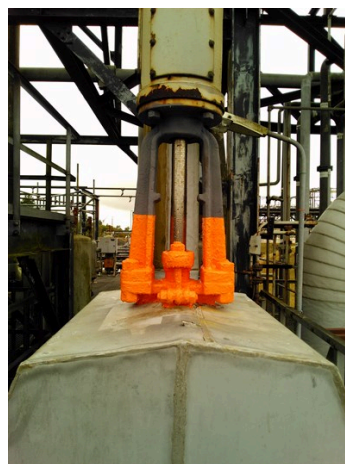
Close up of application

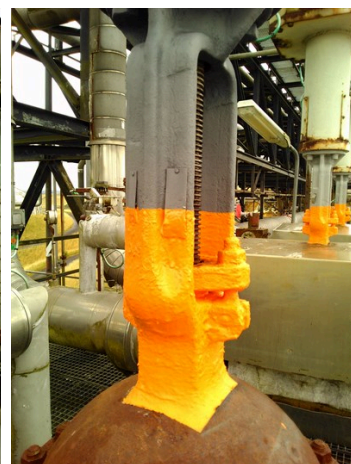
Completed application
