# Belzona repairs & protects control valve

ID: 8889

Industry: *Chemical & Petrochemical*  
Application: *VPF-Valves, Pipes and Fittings*  
Substrate: *Stainless-steel*  
Products: *Belzona 1111 Supermetal*

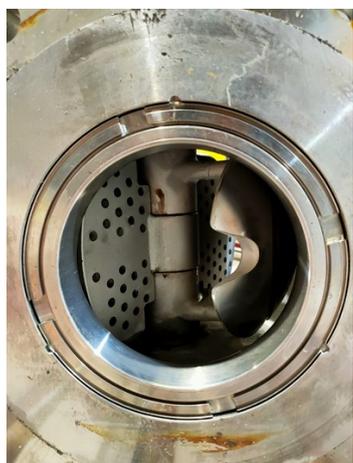
Valve showing internal parts

The valve was disassembled, the critical parts were protected with blasting tape & then the internal surface was prepared to SA2.5 & 75 microns.

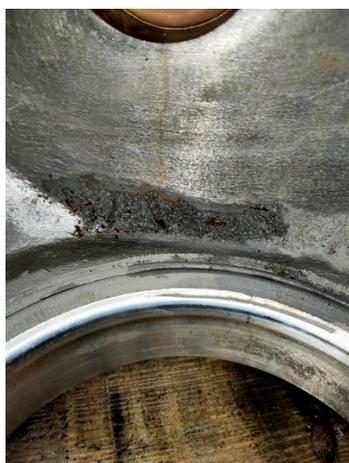
Close up of the cavitation damage

A stainless steel control valve had suffered from cavitation erosion in service. The erosion had gone through wall in some areas of the valve body.

Belzona 1111 was then used to rebuild the lost metal. Two coats of Belzona 1341 Supermetalglide were then applied followed by one coat of Belzona 2141 ACR Fluid Elastomer.

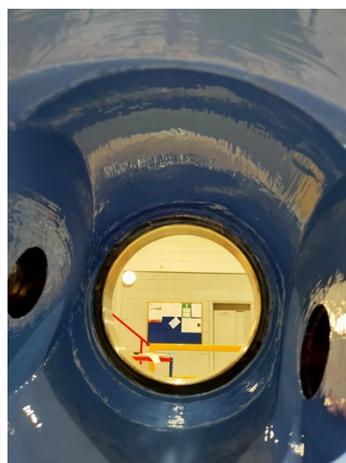
The damage rebuilt & the area coated with Belzona 1341 Supermetalglide
