Belzona seals leaks in clear water storage tank

ID: 8915

Application: TCC-Tanks and Chemical Containment Areas

Substrate: GFRP

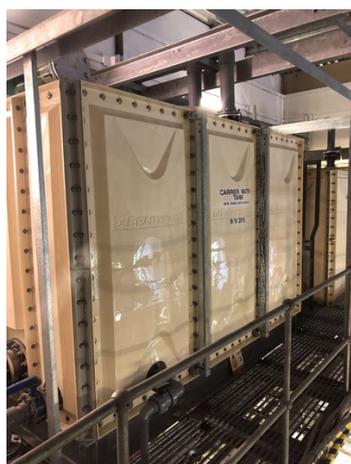
Storage tanks

A clean water storage tank had developed several leaks from the sectional joints that hold the tank together.

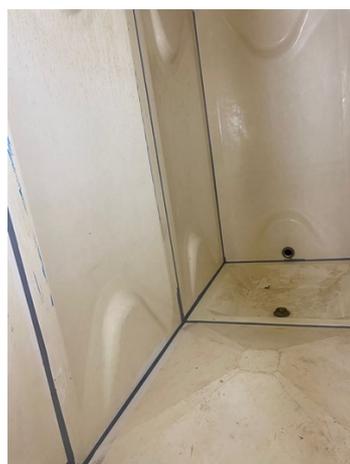
Belzona 1111 applied to fair the gaps between the tank sections

The GRP areas were prepared mechanically to a 40 micron profile. It was decided to repair all the joints to ensure no leaking areas were missed.

Belzona 1111 Supermetal was applied to fill the gap inbetween the joints. Belzona 1981 with Belzona 9381 was then applied as a band over the joint areas.

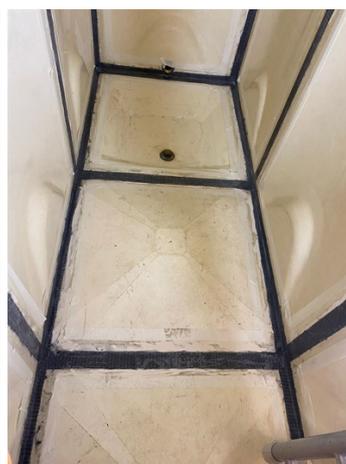
Belzona SuperWrap 2 system applied to the tank joints

The Belzona 1981 SuperWrap II system is able to cope with the movement of the tank during the loading/unloading cycles.

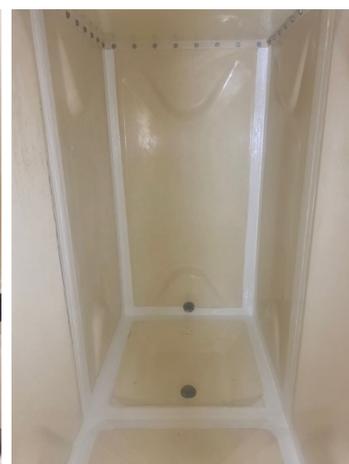
Belzona 5811DW2 applied as a top coat

Two coats of Belzona 5811 DW2 were then applied over the bands to terminate back onto the GRP of the tank.
