# Demonstrated Longevity in an FGD Repair

Customer Location: Coal-Fired Power Plant - Cumberland City, Tennessee USA

Application: VPF-Valves, Pipes and Fittings

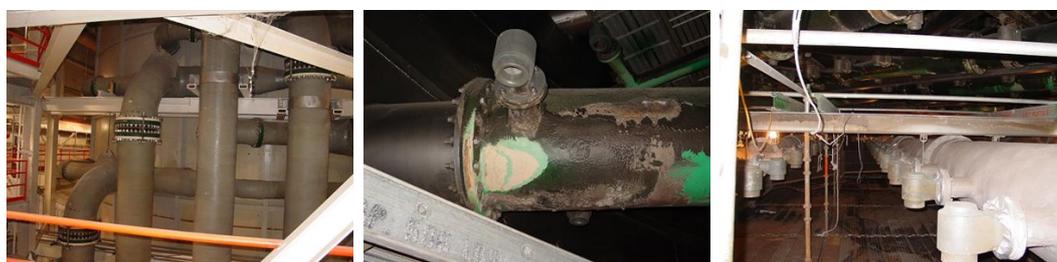
Lime slurry from the four spray levels above had caused an existing polyurea coating to fail exposing the relatively soft FRP piping to the erosive forces of the lime slurry. Should the piping become holed, side streams would decrease the overall scrubbing efficiency resulting in increased operating costs.

- \* Exterior of the FGD at the spray level ,
- \* Severely damaged FRP pipe caused by lime slurry ,
- \* Completed Belzona application to one of six lime slurry header pipes ,
- \* Belzona repair after seventeen months in service ,

Flue gas desulfurization scrubber operating at 200°F (93°C) comprised of five spray levels each with six lime slurry pipes.

Belzona® 5891 and Belzona® 1391 were applied in accordance with a modified Belzona Know-How System Leaflet VPF-2.

Replacement of existing tapered FRP piping would have required an unacceptably long lead time and was considered prohibitively expensive. Belzona was selected because the repair can be conducted quickly and inexpensively in situ while providing the required abrasion, temperature, and chemical resistance.
