Belzona Protects Sulfuric Acid Tank in a Chemical Plant

ID: 8926

Industry: Chemical & Petrochemical
Application: TCC-Tanks and Chemical Containment Areas

Products: Belzona 4311 (Magma CR1), Belzona 4911 (Magma TX Conditioner), Belzona 7311

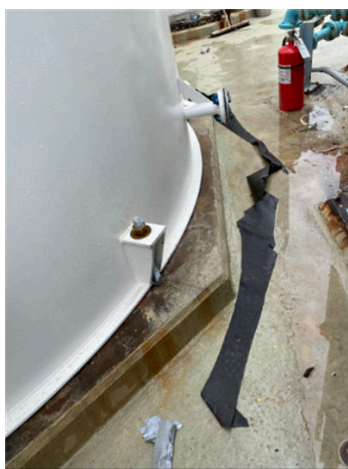
Previous coating was removed.

The tank base was ground, and the previous coating was removed, before Belzona 4911 was used to condition the substrate. Two coats of Belzona 4311 (Magma CR1) were then applied to provide excellent chemical resistance to the tank base. The areas on top of the tank were prepared with a Bristle Blaster to remove paint and to achieve surface roughness to allow pipe supports to be bonded to the top of the tank using Belzona 7311. In total, six 10 inch by 10 inch bottom plates were bonded to tank, initially without additional weight or pressure while the product cured.

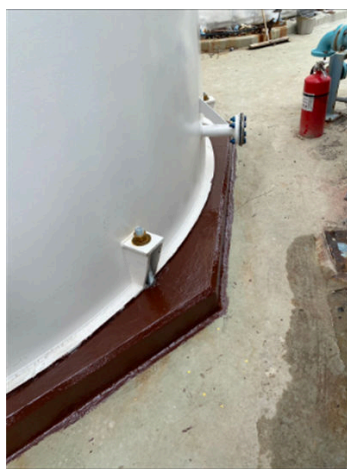
Belzona 4311 applied to provide excellent chemical resistance to the tank base.

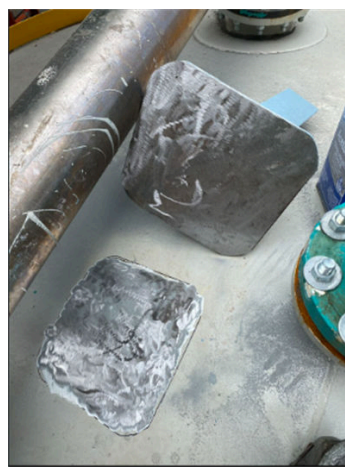
Areas on top of the tank prepared with a Bristle Blaster to remove paint.

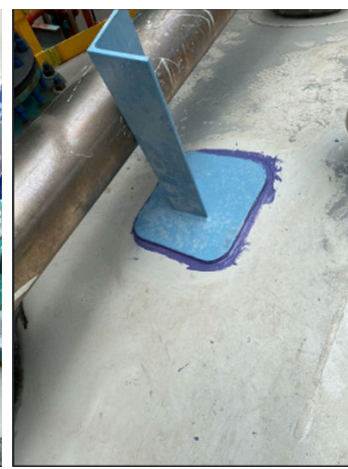
Belzona 7311 to bond pipe supports to the top of the tank.
