Belzona Protects Sulfuric Acid Tank in a Chemical Plant

ID: 8926

Customer Location: Alabama, USA
Application Date: April 2022

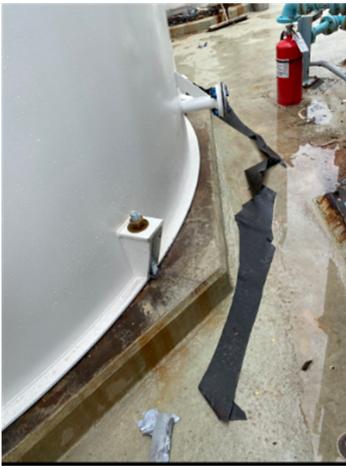
Previous coating was removed.

The tank base was ground, and the previous coating was removed, before Belzona 4911 was used to condition the substrate. Two coats of Belzona 4311 (Magma CR1) were then applied to provide excellent chemical resistance to the tank base. The areas on top of the tank were prepared with a Bristle Blaster to remove paint and to achieve surface roughness to allow pipe supports to be bonded to the top of the tank using Belzona 7311. In total, six 10 inch by 10 inch bottom plates were bonded to tank, initially without additional weight or pressure while the product cured.

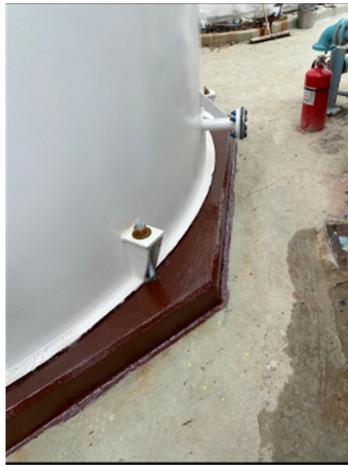
Belzona 4311 applied to provide excellent chemical resistance to the tank base.

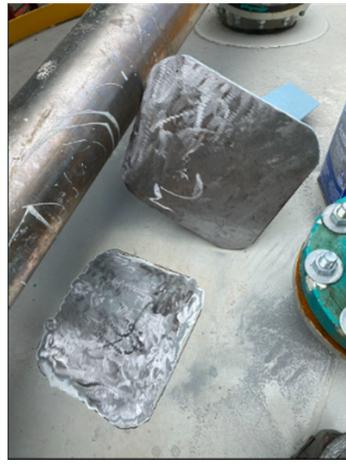
Areas on top of the tank prepared with a Bristle Blaster to remove paint.

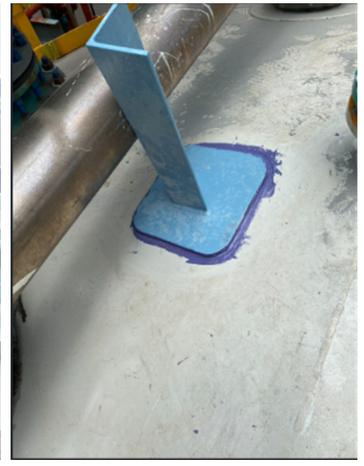
Belzona 7311 to bond pipe supports to the top of the tank.
