# Belzona Protects Sulfuric Acid Tank in a Chemical Plant

ID: 8926

**Industry:** Chemical & Petrochemical  
**Application:** TCC-Tanks and Chemical Containment Areas  
**Substrate:** Carbon steel  
**Products:** Belzona 4311 (Magma CR1), Belzona 4911 (Magma TX Conditioner), Belzona 7311

**Customer Location:** Alabama, USA  
**Application Date:** April 2022

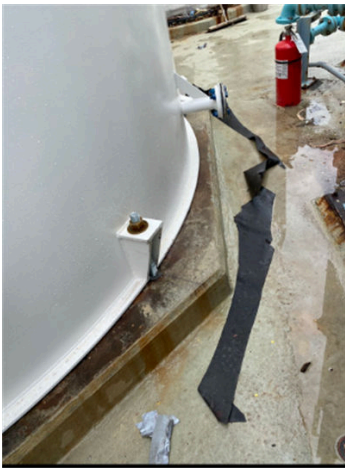
Previous coating was removed.

The tank base was ground, and the previous coating was removed, before Belzona 4911 was used to condition the substrate. Two coats of Belzona 4311 (Magma CR1) were then applied to provide excellent chemical resistance to the tank base. The areas on top of the tank were prepared with a Bristle Blaster to remove paint and to achieve surface roughness to allow pipe supports to be bonded to the top of the tank using Belzona 7311. In total, six 10 inch by 10 inch bottom plates were bonded to tank, initially without additional weight or pressure while the product cured.

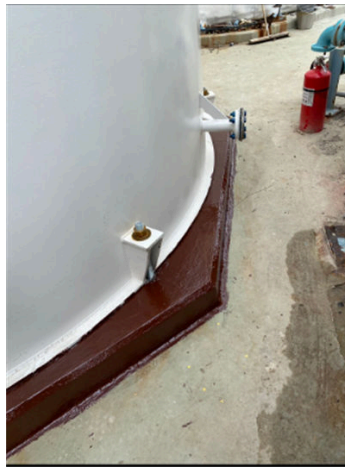
Belzona 4311 applied to provide excellent chemical resistance to the tank base.

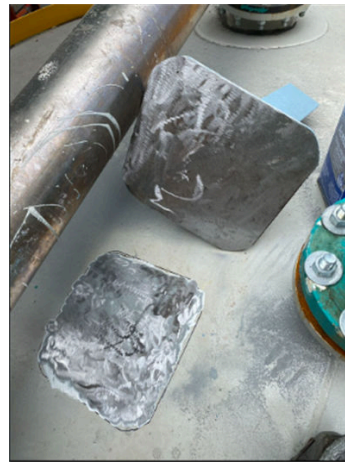
Areas on top of the tank prepared with a Bristle Blaster to remove paint.

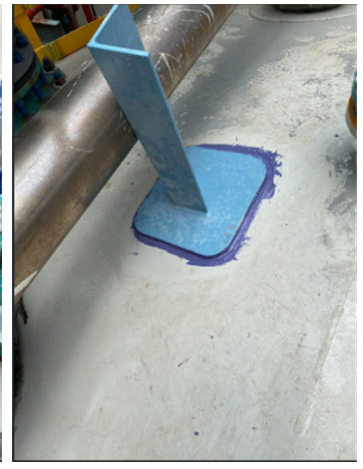
Belzona 7311 to bond pipe supports to the top of the tank.
