BELZONA® 3211 PROTECTS LPG SPHERES

ID: 90

Pressurized storage spheres for Liquefied Petroleum Gas (LPG).

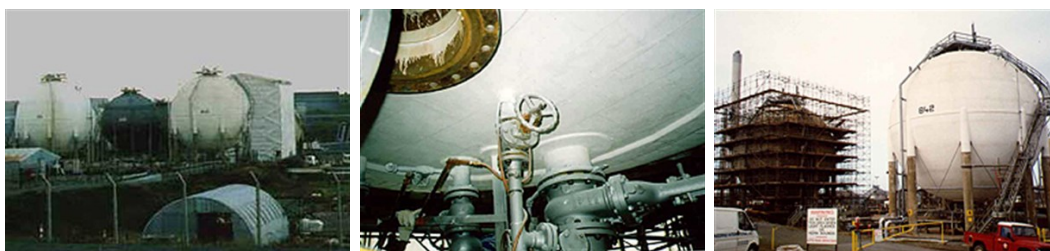
Water penetration through original insulation system had allowed severe underlagging corrosion to occur. The site is an exposed marine site and deluge systems on the sphere are regularly tested so that watertightness is imperative.

- * Work underway on one of the spheres within the environmental screen ,
- * Close up of the application showing complete sealing around pipework ,
- * A completed sphere ,

The insulation was re-installed using a closed cell foam glass that is impervious to water and Belzona® 3211 applied in accordance with Belzona Know-How Leaflet TCC-4.
