# Cool-to-Touch Coating Protects Hazardous Hot Pipe at Offshore Platform

ID: 9011

Industry: Oil & Gas  
Application: VPF-Valves, Pipes and Fittings  
Substrate: Carbon steel  
Products: Belzona 5871

Customer Location: East Java , Indonesia  
Application Date: December 2022

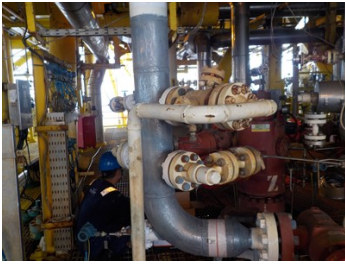
Surface preparation with hand tools on bare metal after aluminium cladding removal

*The damaged existing thermal insulation needed to be replaced, exposing the hot surface of the pipe and endangering the safety of all personnel working or walking near the pipe at offshore platform.*

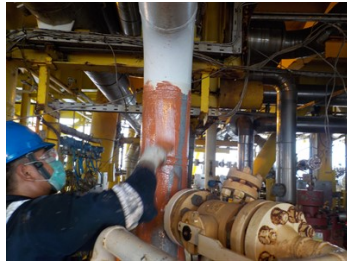
Applying 3 coats of Belzona 5871 by brush

The application was carried out in accordance with Belzona Know-How System Leaflet VPF-2. Three coats of Belzona 5871 was applied to reduce the surface temperature of the pipe to be a level safe for contact.

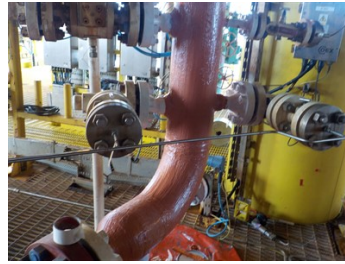
Leave the applied coating to expand by foaming and cure
