Cool-to-Touch Coating Protects Hazardous Hot Pipe at Offshore Platform

ID: 9011

Industry: Oil & Gas
Application: VPF-Valves, Pipes and Fittings
Substrate: Carbon steel
Products: Belzona 5871

Customer Location: East Java , Indonesia
Application Date: December 2022

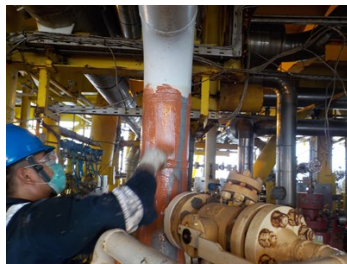
Applying 3 coats of Belzona 5871 by brush

The application was carried out in accordance with Belzona Know-How System Leaflet VPF-2. Three coats of Belzona 5871 was applied to reduce the surface temperature of the pipe to be a level safe for contact.

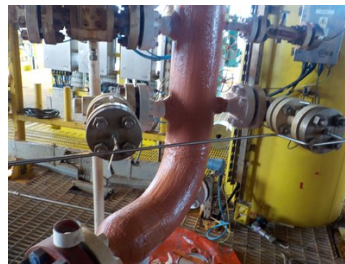
Leave the applied coating to expand by foaming and cure

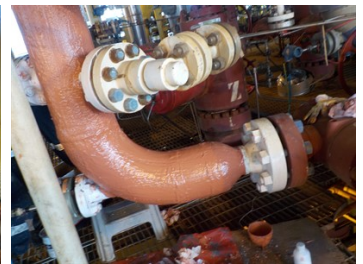
Application completed and pipe is safety to touch
