Cool-to-Touch Coating Protects Hazardous Hot Pipe at Offshore Platform

ID: 9011

Industry: Oil & Gas
Application: VPF-Valves, Pipes and Fittings
Substrate: Carbon steel
Products: Belzona 5871

Customer Location: East Java , Indonesia
Application Date: December 2022

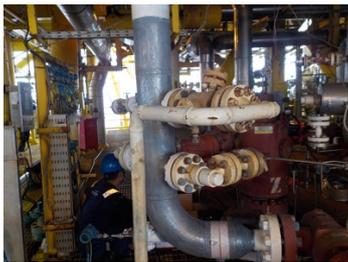
Surface preparation with hand tools on bare metal after aluminium cladding removal

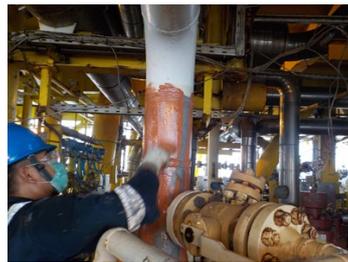
Applying 3 coats of Belzona 5871 by brush

The application was carried out in accordance with Belzona Know-How System Leaflet VPF-2. Three coats of Belzona 5871 was applied to reduce the surface temperature of the pipe to be a level safe for contact.

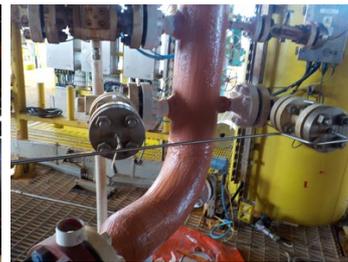
Leave the applied coating to expand by foaming and cure

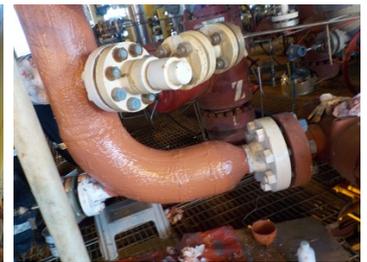
Application completed and pipe is safety to touch
