# Belzona Helps Extend Dredge Pump Run Time

ID: 9029

Industry: Marine  
Application: CEP-Centrifugal Pumps  
Substrate: Other  
Products: Belzona 1331, Belzona 1814

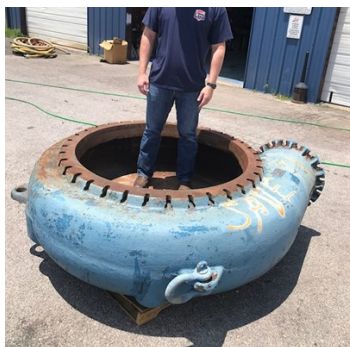
Large Pumps Arrive at the shop for coating

Pump was brought to the shop

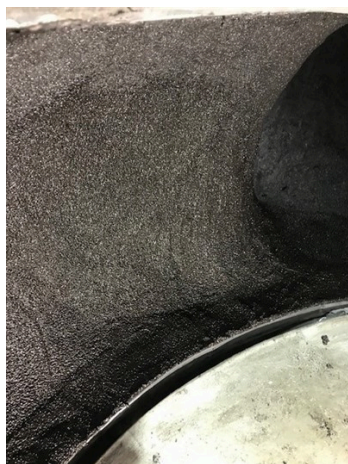
Belzona 1814 applied inside

"Priming" coat of 1331 was applied to help with increasing shear adhesion of the 1814

1/4" of 1814 applied to the entire pump internals.

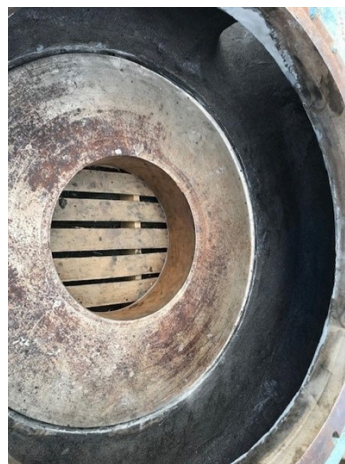
Belzona 1814 applied to all wear areas of the pump
