Belzona protects 98% sulphuric acid chemical containment area

ID: 9032

Industry: Chemical & Petrochemical
 Application: TCC-Tanks and Chemical Containment Areas
 Substrate: Concrete
 Products: Belzona 4311 (Magma CR1)

Customer Location: Croatia
 Application Date: June 2009

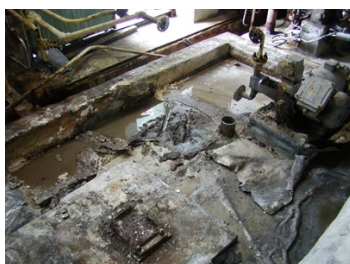
Chemical containment area protected by lead cover failed.

Damaged chemical containment area

Application was carried out in accordance with TCC-15. Concrete under the lead cover needed to be rebuilt with new concrete with chemical resistant tiles and protected with Belzona 4311.

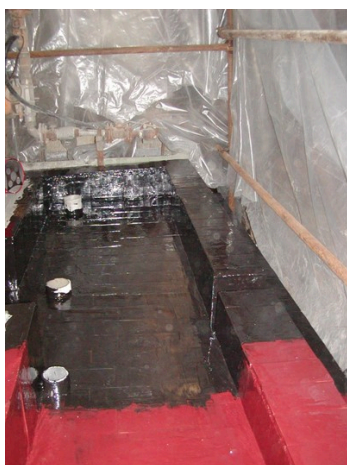
Protection of chemical containment area in progress

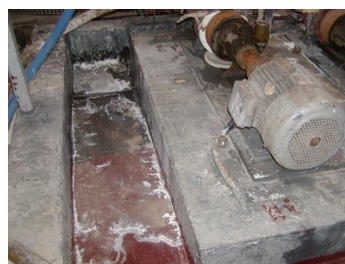
No deterioration shown after 5 years

After 5 years in service Belzona showed no deterioration.

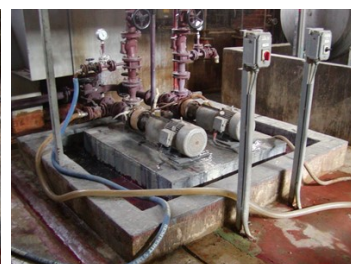
No deterioration shown after 5 years
