Belzona Provides Economical Coating for Large Cooling Water Impeller

ID: 9042

Industry: Oil & Gas
Application: CEP-Centrifugal Pumps
Substrate: Cast Iron
Products: Belzona 5821

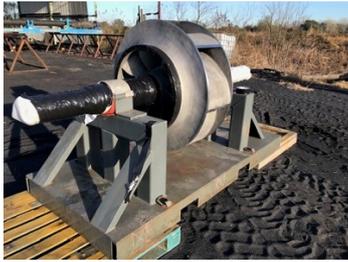
Impeller prior to the application

Blasted to SP10 minimum 3 mil profile per the IFU

Two coats of Belzona 5821 were applied to the impeller wet areas.

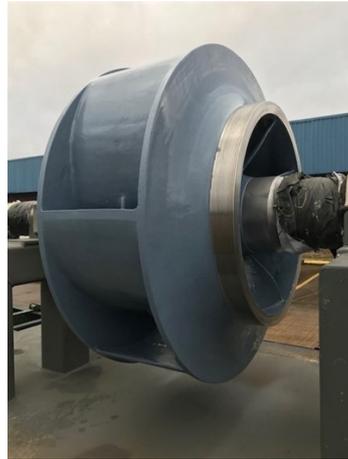
Completed application
