# Belzona wins Against Coal Tar Alternative

ID: 9043

Industry: Oil & Gas  
Application: CEP-Centrifugal Pumps  
Substrate: Cast Iron  
Products: Belzona 5811 (Immersion Grade)

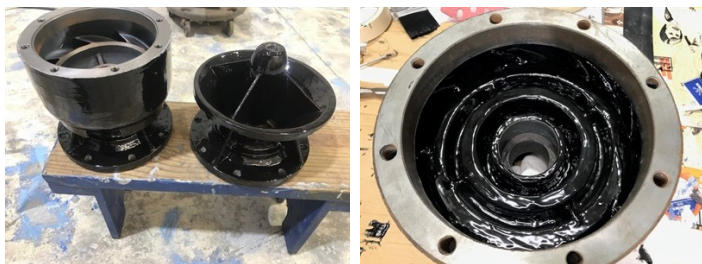
*This client had been using coal tar as their pump protection for years. They wanted something better but still lower cost and finally gave Belzona 5811 a try after being show the performance data from the PSS.*

Blasted to SP10, modified CEP-03 leaflet was used.

two coats of 5811 applied to internals and externals of the bowl and suction bell
