Belzona 1593 protects critical areas in 15 storage tanks

ID: 9052

Industry: Chemical & Petrochemical
Application: TCC-Tanks and Chemical Containment Areas
Substrate: Carbon steel
Products: Belzona 1593

Customer Location: Rotterdam Botlek
Application Date: June 2022

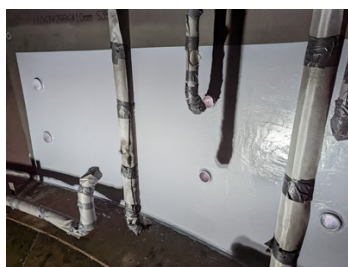
First layer Belzona 1593 at the coil inlet

Substrate was masked and grit blasted. The profile was measured and well above 75um. After stripe coating on the welds and corners, two layers of Belzona 1593 were applied by brush and applicator. For each tank a test panel was made and tested for adhesion. All test panels were tested with dolly pull-off.

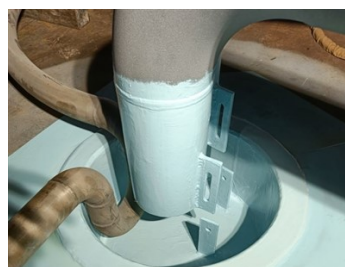
Two layers Belzona 1593 in the sump
