Belzona SuperWrap II secures integrity of pipeline

ID: 9054

Industry: Chemical & Petrochemical
Application: VPF-Valves, Pipes and Fittings
Substrate: Carbon steel
Products: Belzona 1983 (SuperWrap II)

Customer Location: Rotterdam
Application Date: March 2023

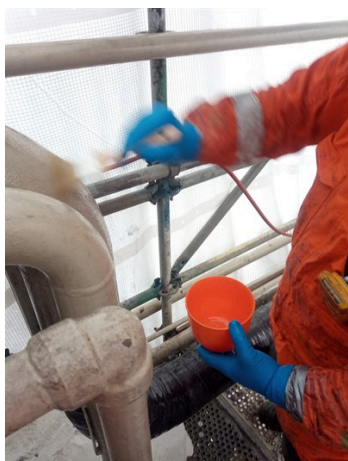
Surface preparation. A thin layer of Belzona 1983 onto the pipe.

To bring strength back to this pipe we offered a Belzona SuperWrap II. No leaks were detected, so Belzona SuperWrap was applied directly on the hot pipe at 30 degrees Celcius. A small landing area was created on both ends of the wrap, so it would have a good adhesion. In total 3 layers were applicated on the straight parts and 6 layers on the corners.

At critical area's like support's and flanges the area was grinded with MBX Bristle Blaster. Also the landing area's (300 mm wide) were prepared with MBX Bristle Blasters (ATEX).

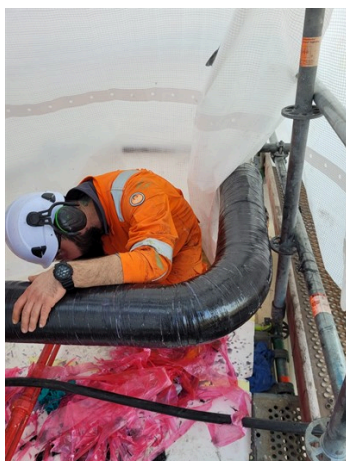
After curing removing the Belzona 9382 tape to inspect the application

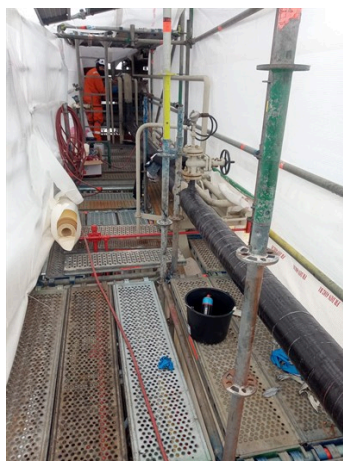
First 5 meters of Belzona SuperWrap completed. 35 meter to go.

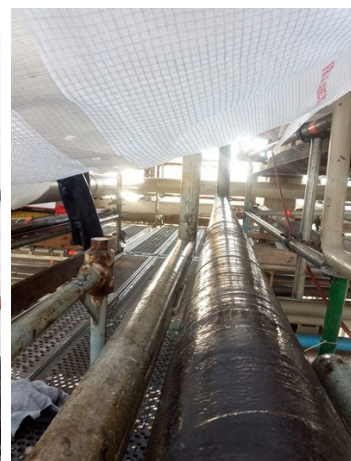
Finished application halfway the pipe.

In total 30 meters of pipeline was wrapped by the Super Wrap II
The integrity op this pipeline is reassured without any downtime and production stop.
