Belzona SuperWrap II secures integrity of pipeline

ID: 9054

Industry: Chemical & Petrochemical
Application: VPF-Valves, Pipes and Fittings
Substrate: Carbon steel
Products: Belzona 1983 (SuperWrap II)

Customer Location: Rotterdam
Application Date: March 2023

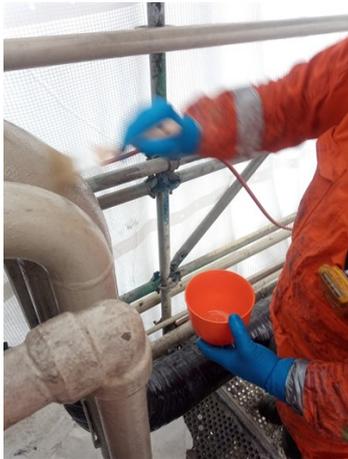
Surface preparation. A thin layer of Belzona 1983 onto the pipe.

To bring strength back to this pipe we offered a Belzona SuperWrap II. No leaks were detected, so Belzona SuperWrap was applied directly on the hot pipe at 30 degrees Celcius. A small landing area was created on both ends of the wrap, so it would have a good adhesion. In total 3 layers were application on the straight parts and 6 layers on the corners.

At critical area's like support's and flanges the area was grinded with MBX Bristle Blaster. Also the landing area's (300 mm wide) were prepared with MBX Bristle Blasters (ATEX).

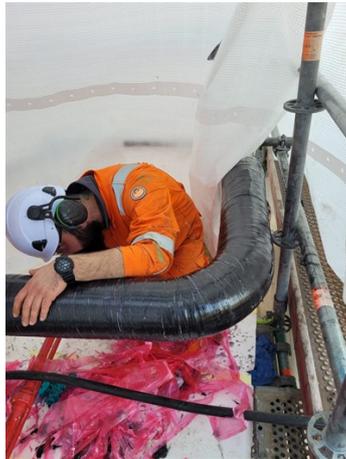
After curing removing the Belzona 9382 tape to inspect the application

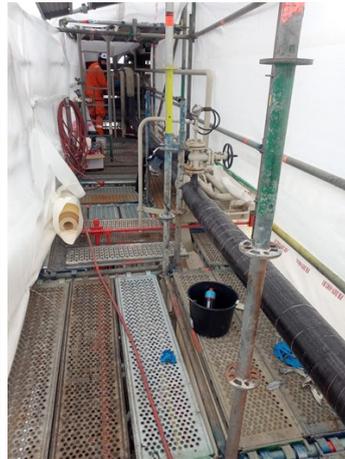
First 5 meters of Belzona SuperWrap completed. 35 meter to go.

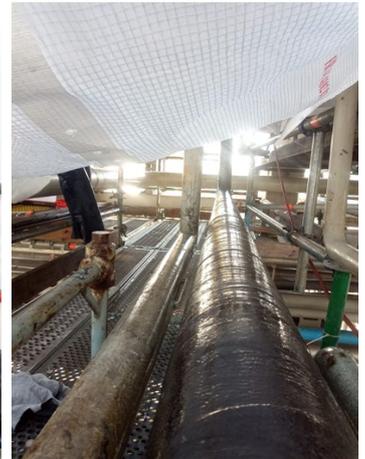
Finished application halfway the pipe.

In total 30 meters of pipeline was wrapped by the Super Wrap II
The integrity of this pipeline is reassured without any downtime and production stop.
