# Belzona Bonds Pipe Supports on top of a Chemical Tank Roof.

ID: 9067

Industry: *Chemical & Petrochemical*  
Application: *TCC-Tanks and Chemical Containment Areas*  
Substrate: *Carbon steel*  
Products: *Belzona 7311*

Customer Location: *Alabama*  
Application Date: *May 2022*

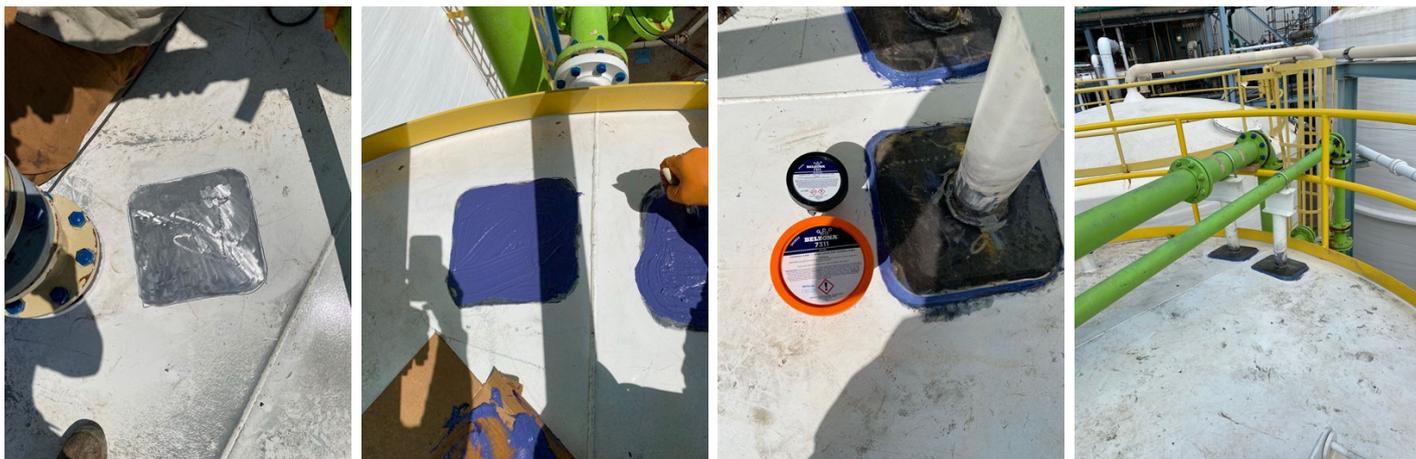
*Installation of five 12"x12" pipe supports on top of a newly rubber-lined Sulphuric Acid (H2SO4) tank.*

Pipe supports on top of a Chemical Storage Tank within a Petrochemical facility.

The five support areas were ground to SSPC-SP11 cleanliness and a 75 microns profile, prior to the Belzona 7311 being applied at the recommended 2mm thickness onto the tank roof and pipe support. The application was carried out in accordance with Belzona System Leaflet TCC-06.

Welding was not an option as it would have burned the internal tank lining. The Customer was very impressed with the ease of application and performance of Belzona 7311, successfully winning the Distributor a couple more pipe support bonding applications.
