Encapsulating a Steel Plate Between New and Old Concrete in a Discharge Sump

ID: 9071

Industry: *Pulp & Paper* Customer Location: *New Brunswick*
Application: *TCC-Tanks and Chemical Containment Areas* Application Date: *May 2023*
Substrate: *Concrete*
Products: *Belzona 1161 (Super UW-Metal), Belzona 4911 (Magma TX Conditioner), Belzona 5831LT*

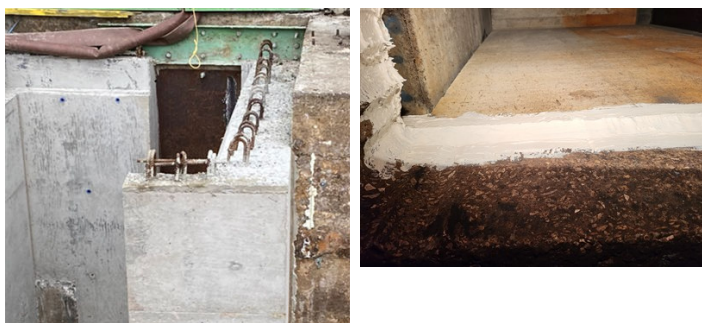
A new foundation was poured up against an old building to extend a discharge sump in a paper mill. A steel plate was cut out and the joint needed to be sealed along with the remaining cut steel edges. With only a 12 hour shutdown window to complete the entire project.

Steel plate, uncut, before the concrete floor and surrounding building were installed. Sealed seam, concrete-steel-concrete.

Due to the short window, perfect drying of both the substrate and the product was not going to be possible. Needed a system that is surface tolerant and also able to be put back into water service quickly.

Surface was prepared using grinders and hand tools inside the sump. Then cleaned out and dried as long as possible before application of the conditioner.
