# Belzona Patches Heated Oil Jacket

ID: 9074

Industry: Chemical & Petrochemical  
Application: TCC-Tanks and Chemical Containment Areas

Customer Location: Shreveport, LA  
Application Date: May 2023

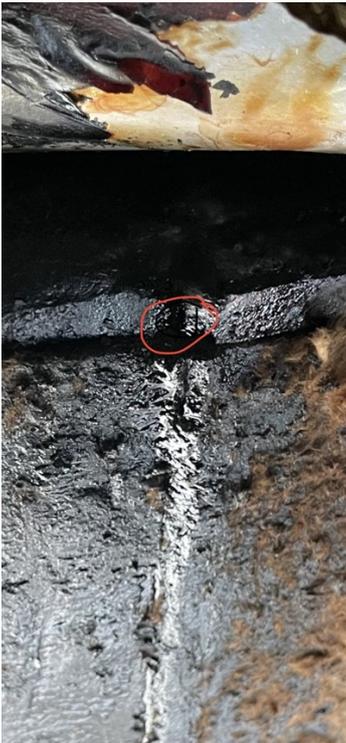
Customer had a pinhole leak in corner of heated oil jacket. It was not possible to drain this jacket as it was tied into the other 73 tanks.

Pinhole leak in oil jacket

This jacket was not able to be drained and/or shut down due to it being tied into system with other 73 tanks. Belzona was able to provide a live leak repair saving them thousands of dollars in repair costs and lost production as well as preventing future issues from purging this system and having to refill it and heat it back up again.

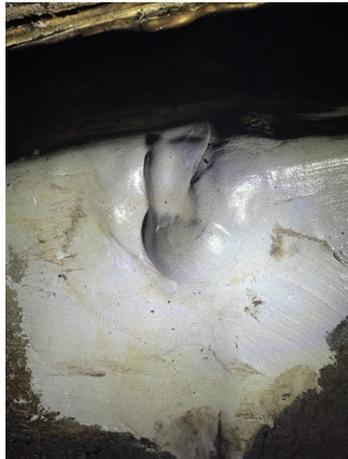
Live leak plugged with Belzona 1221

Belzona 9611 was used to plug the hole with Belzona 1221 used as reinforcement. Once that was cured and leak was stopped, Belzona 1511/9341 was used to create a patch over the top of the leak for rebuild/reinforcement.

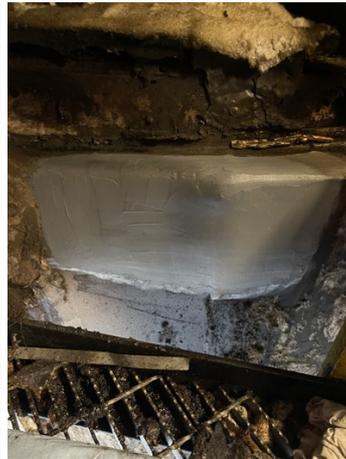
Belzona 1511 used to rebuild the area
